Pool and Spa Chlorinator Safety Accident Prevention Alert

The Next Three Seconds Protects Your Life, Your Loved Ones, Your Livelihood®

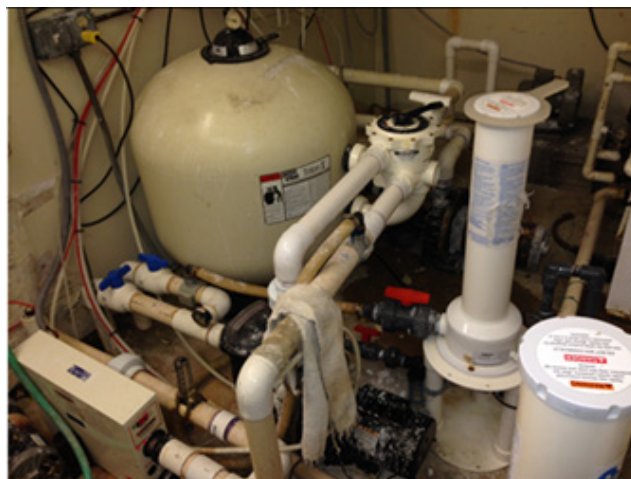
A serious injury occurred when an employee was attempting to unclog a pool and spa chlorination system; the clog was caused by an undissolved calcium-hypochlorite puck. The employee's face was over the top of the puck sleeve when the pressure was relieved. As he was watching the system clear, a spout of water struck the employee in the face and neck causing first and second degree chemical burns, despite quick intervention with emergency eyewash. Safety glasses were worn at the time, but no other PPE was donned.

The employer lacked controls for proper employee training, preventative maintenance practice, vendor controls for regular reviews of the system, and when a third-party should be called rather than relying on internal maintenance personnel.

Lockout/Tagout practices were not completed. The employer lacked proper equipment specific to lockout/tagout practices to ensure that employees were not performing duties on a live system.

- Ensure that proper contractor maintenance programs are in place to service equipment when the work is beyond the internal knowledge base as a method of risk avoidance.

- Develop and follow proper written lockout/tagout procedures to ensure there is no stored pressure/energy on the system before service commences.
- Ensure that employees are fully trained in hazard communication and have reviewed the safety data sheets for appropriate safety practices.

- Ensure that all appropriate PPE is in place such as safety glasses, face shield, chemical resistant gloves, chemical apron, long sleeve shirt, long pants and closed toed shoes.

- Ensure that preventative maintenance by a third-party is sufficient in capturing all elements of the system where a future failure might occur.
- Ensure that emergency eye wash and body showers are readily available in the immediate area where chemical systems are used. Eyewashes and showers must be capable of at least 15 minutes of continuous flow of tepid water.

- Evaluation of alternative methods of sanitization and or supplier of the pucks from salt systems to purchasing a high grade of puck that dissolves more fully in water.
